StrongARM^{**} SA-1100 Microprocessor

Specification Update

November 1998

Order Number: 278105-006

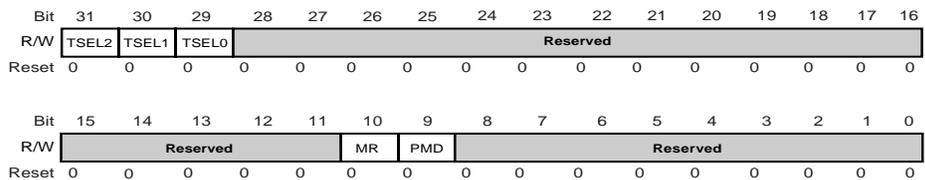
A6071-02

Test Unit Control Register (TUCR)

The Test Unit Control Register (TUCR) contains control bits that put the SA-1100 in various test modes. It is recommended that the operating system write protect these registers under normal conditions to prevent them from being inadvertently written. The following figure shows the format of this register. At reset reserved bits are zero. Writing reserved bits to one can lead to UNPREDICTABLE results.

Bit	Name	Description
0..5	Reserved	—
6	Reserved	—
7	Reserved	—
8	Reserved	—
9	PMD	Power management disable. When PMD is set, sleep mode is disabled and the SA-1100 ignores the ForceSleep bit, as well as the BATT_FAULT and VDD_Fault pins. This bit is cleared on hard reset.
